# BARN REGISTER FORM

## Idaho Heritage Barns Preservation Idaho

<b>Farm Name:</b> Mack & Rita Miller Farm	<b>Property Location:</b> Address: East end of Roseberry Rd. City: Donnelly State: Idaho Zip: 83615 <b>County:</b> Valley
<b>Historic</b> (or other names associated with farm): Brad Barker barn	<b>Legal Description:</b> Township: N or S Range: W or E Section: ¼ Section: NW,NE,SW,SE Latitude: Longitude:
<b>Property Owner:</b> Name: Mack & Rita Miller Address: Box 297 City: Donnelly State: Idaho Zip: 83611 Phone: 469-9152 Email: Mackrita@msn.com	<b>Directions:</b>

The Brod Barker Barn owned by Mac and Rita Miller.

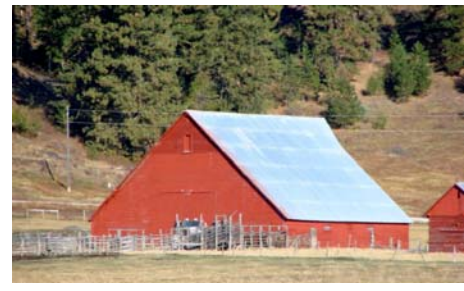
New doors and windows were installed in the early 90s in the original openings. Barn features a widows peak.

Barn foundation handpoured cement. Footings on outside wall are L fitting. Why east side barn has slipped – the L footings don't hold as well as the T. No footings on end walls, just on the sides.
